# Defect detection and classification on metallic parts

Pierrick BOURGEAT and Fabrice MERIAUDEAU \*

IUT – LE2I

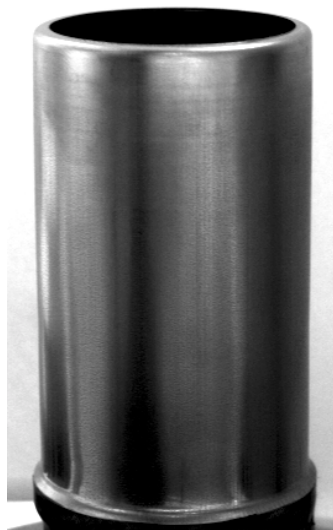
Fig 1 : Metallic part to be inspected.

This paper deals with a machine vision system designed to control and inspect metallic parts. These parts (see figure 1) are mechanically processed leading to various mechanical defects .

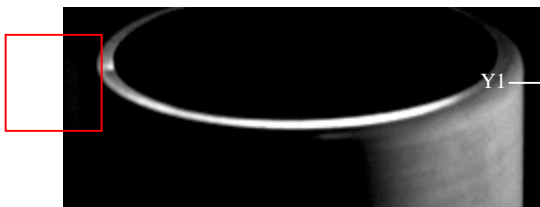
Fig 13: Original image

Defects having their signature only on one peculiar spot (figure 13), the first stage is to locate this peculiar window on the tube. This is done by thresholding the original image (figure 13) using a very low threshold (figure 14) so as to totally reveal the crown.

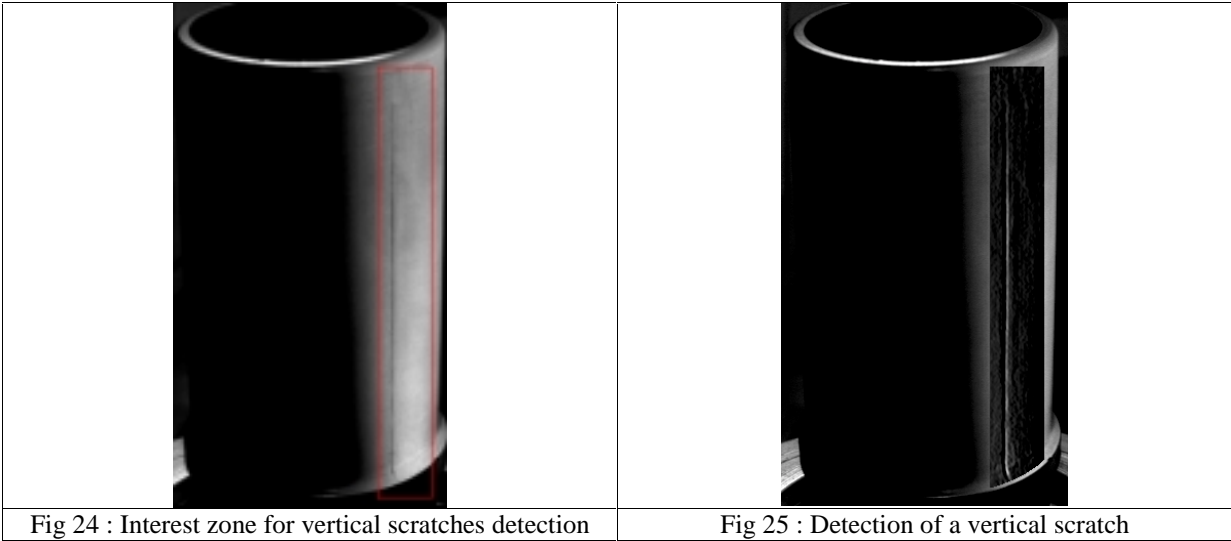
Fig 24 : Interest zone for vertical scratches detection

Fig 25 : Detection of a vertical scratch

The vertical scratches are found using the same procedure but by looking inside longer and narrower windows. Figure 24 and 25 show the detection of a vertical scratch.
